RE: Site Inspection, Great Salt Lake Minerals (GSL), Little Mountain
Solar Project & Plant, M/057/002, Weber County, Utah

Date of Inspection: March 25, 2004
Time of Inspection: 12:30 – 1:30 p.m.
Conditions: Sunny, clear & warm
Participants: Bill Coleman; Brad Bryner, GSL; Wayne Hedberg and Lynn
Kunzler, DOGM

Purpose of Inspection: To check site conditions on a portion of the solar evaporation project and to give Wayne Hedberg a partial overview of the project area.

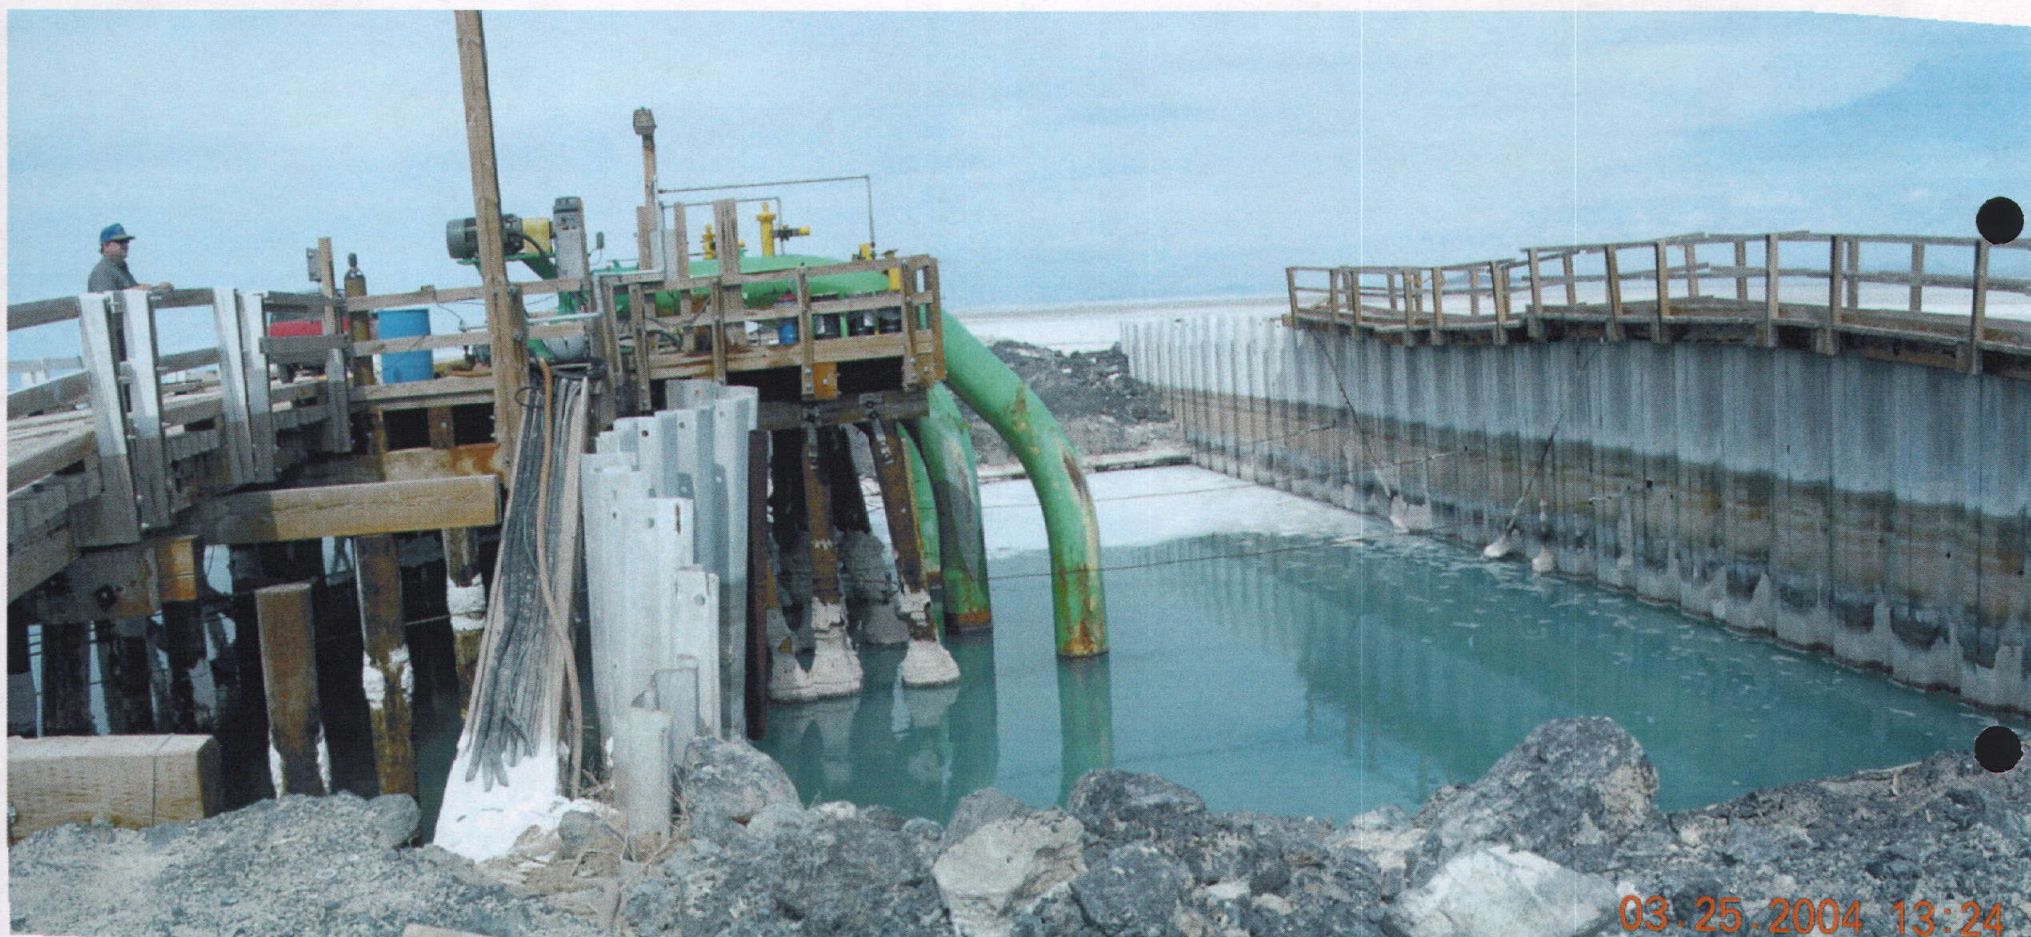
We stopped first at pump station #112 that had four pumps of which only one was currently connected. Three pumps had been removed and placed on the ground. They are scheduled to be reconditioned. One or two might be relocated to a new pump station being built about a mile or so west of this station (photos taken). We proceeded west along the dike driving past the new

1 pump station (?) - 4 pumps (3 were pulled - none active)

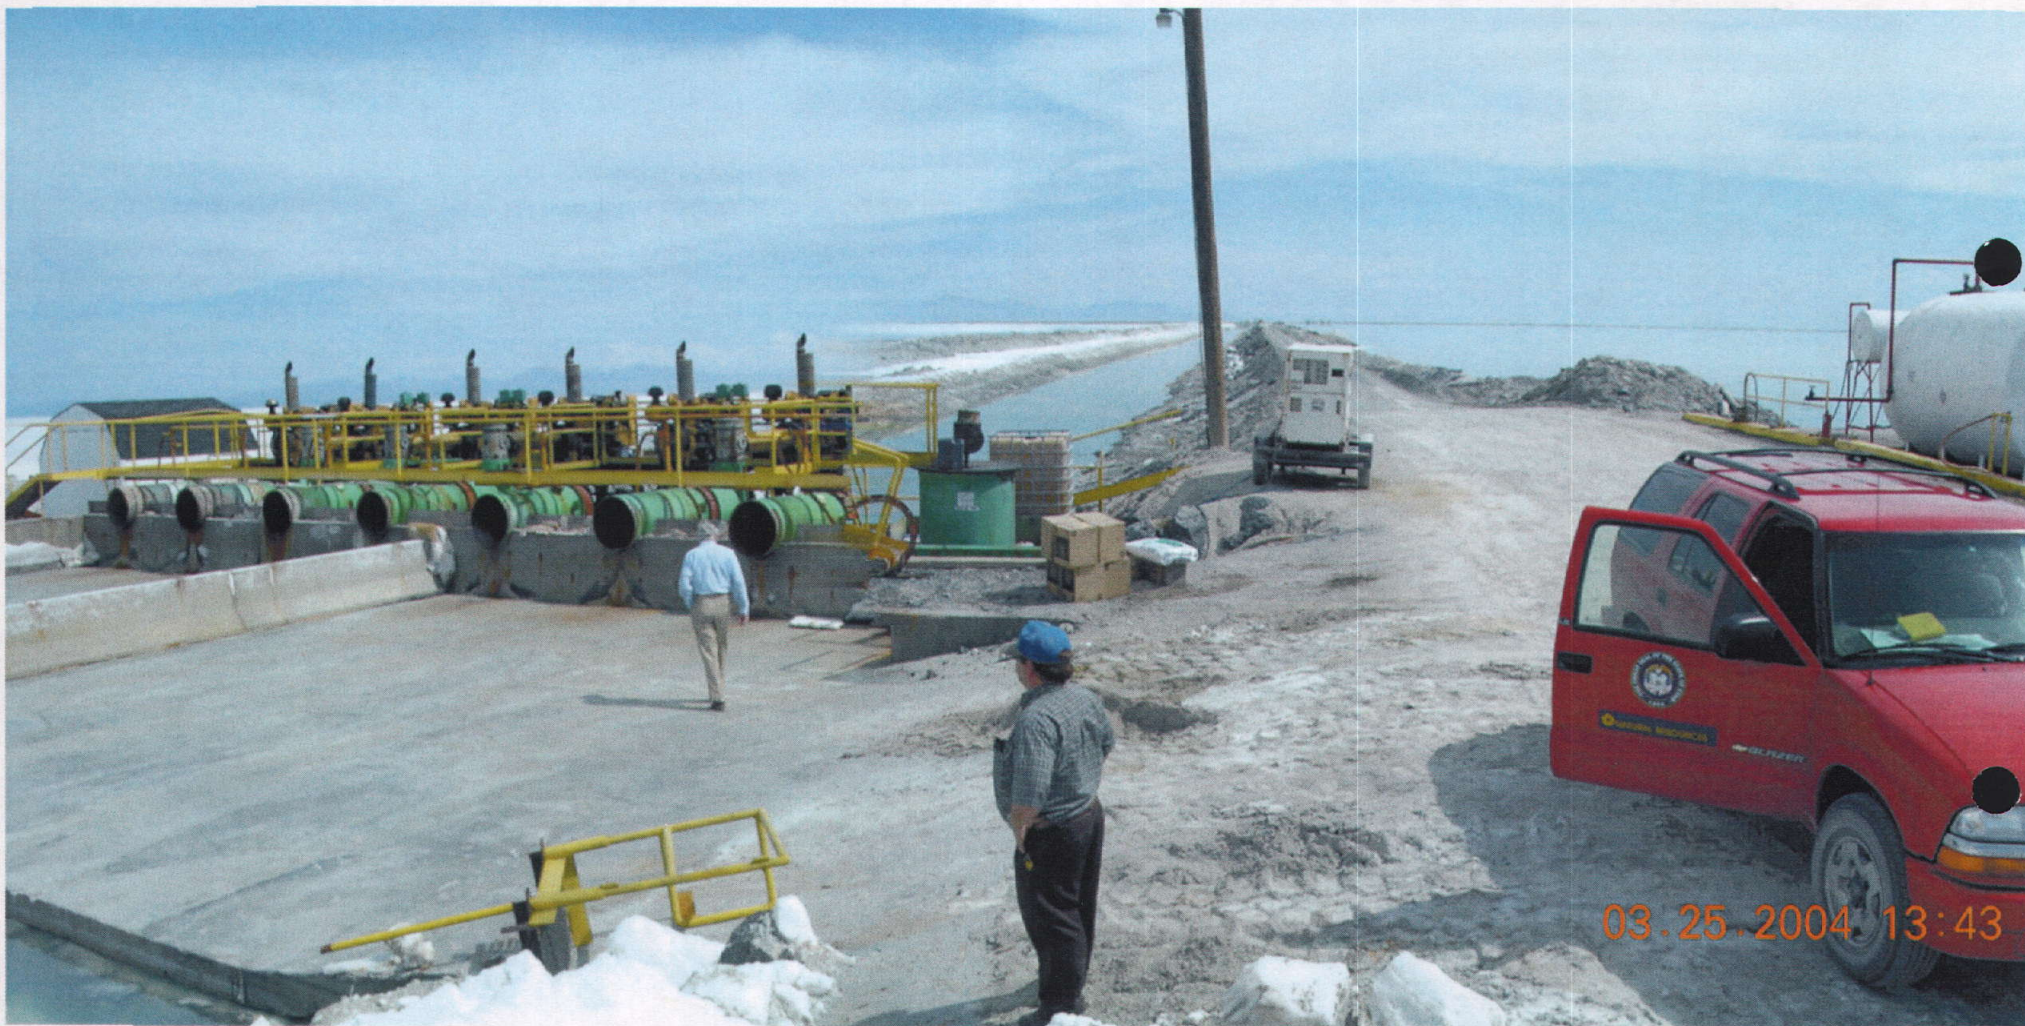
pump station that was under construction (no photos taken here). We stopped at pump station #113 where eight pumps are currently located. A couple of these pumps and motors had been pulled as well. Mr. Bryner stated that neither of the pump stations have been reactivated to fill the ponding system yet. The new pump station is being built to assist the operation in locating and moving the brines into their evaporative system. Several photos were taken to document the pump station conditions.

1 pump missing
in this
composite
(are 8 pumps)
at this station

Large pump station near ^{west} end of dike separating ponds 1 & 2.
Eight pumps exist, although "stitched" photo only shows 7.
(view is looking east)

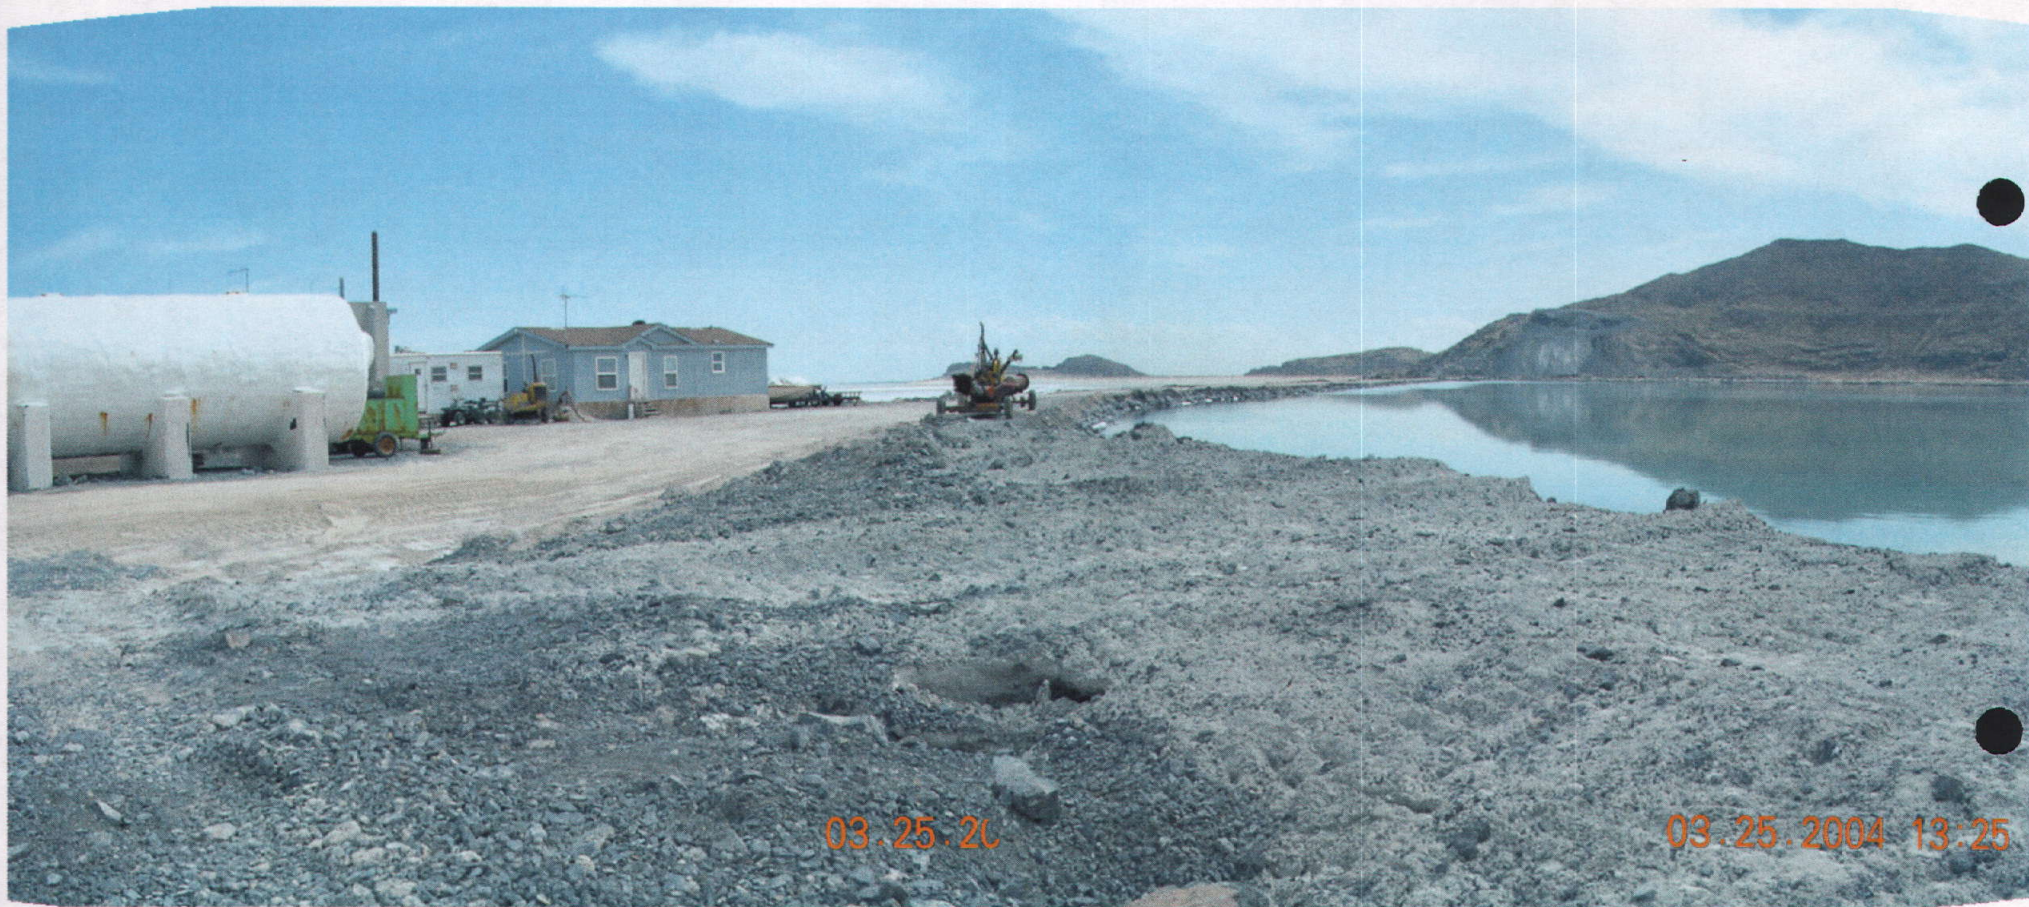
1st pump station (4 pumps) - note limestone quarry borrow site opposite end of pond. View is looking east.

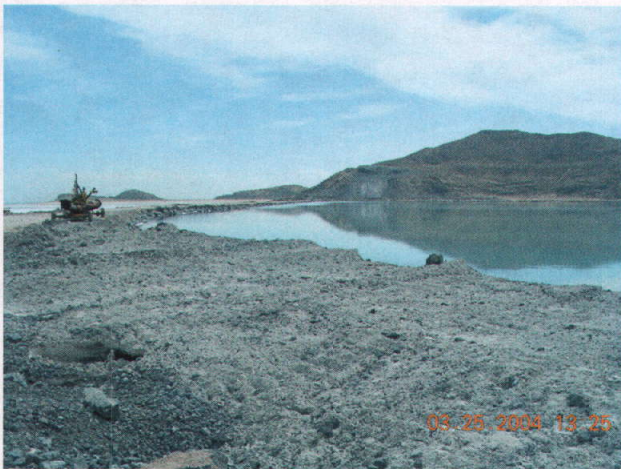
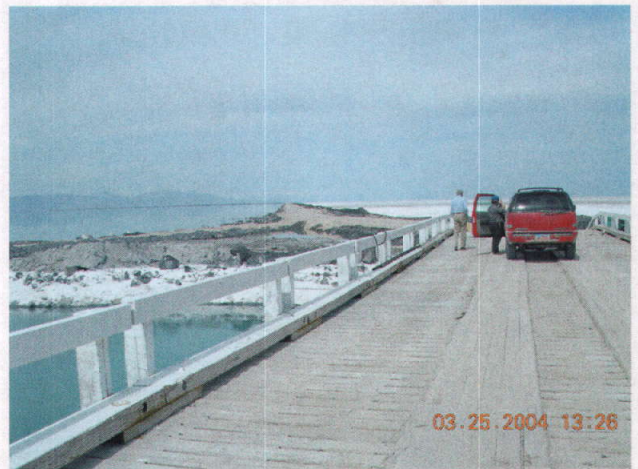
1st
pump
station

(Looking east)

(Looking west)

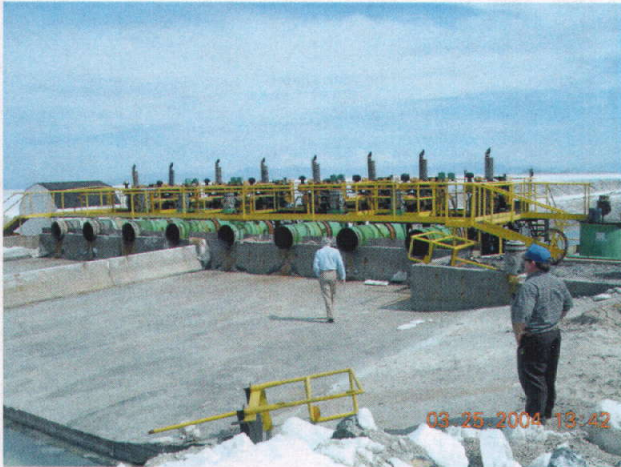
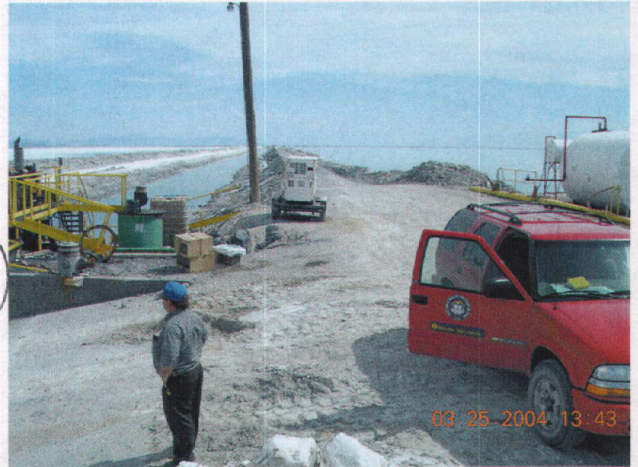
3rd
pump
station
(furthest
west)
8 pumps

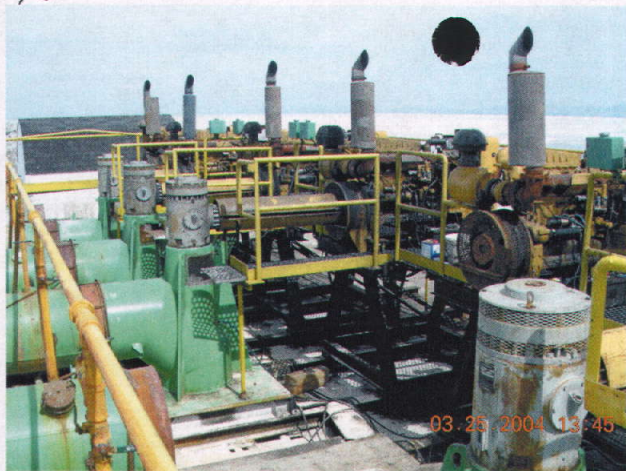
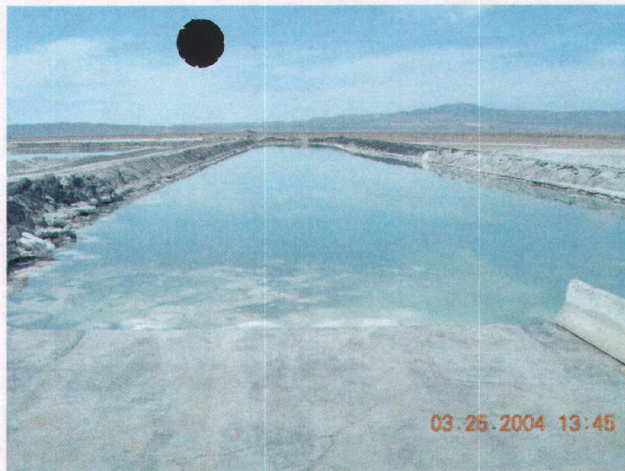
3rd
pump
station

view to
the
west

(discharge canal)

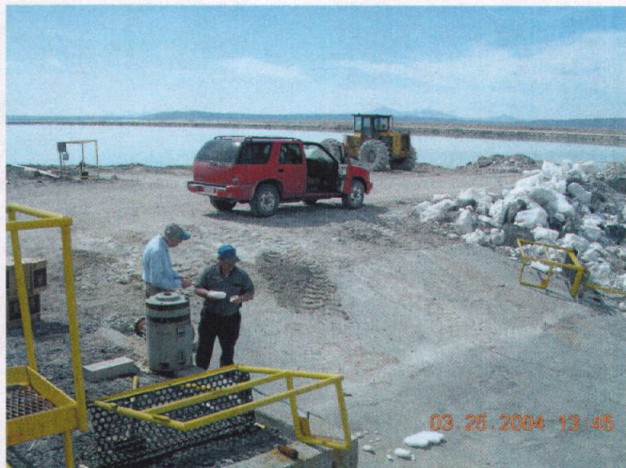
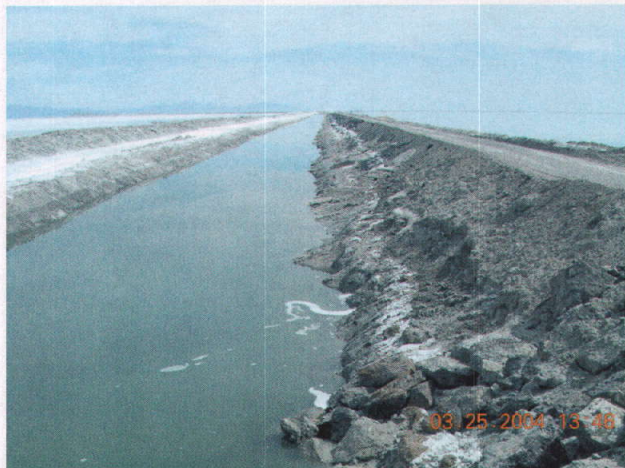
3rd
pump
station

view
to the
east

(intake canal)
